Manhole Inspection Summary

Manhole # S25GG1016MH

Insp Date: **1/19/07 10:54 AM**

Location Address: **4130 FALLS RD**

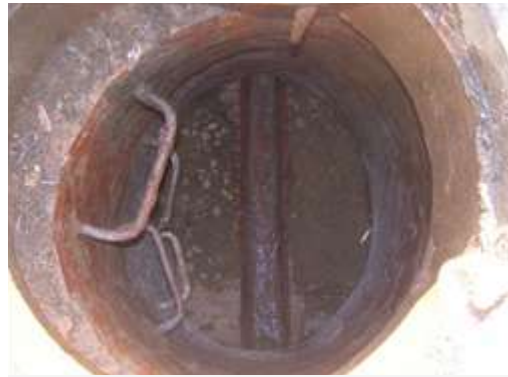
Top View

Corroded steps. Evidence of surcharge - Bench debris.

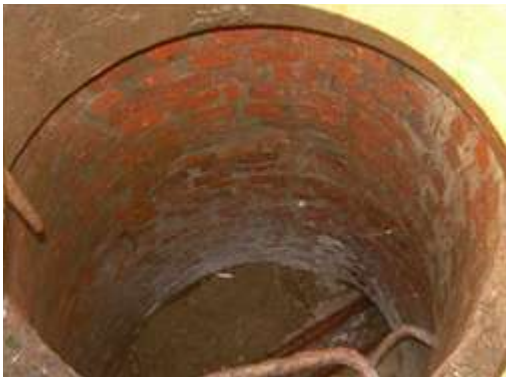
Defect

Frame leaks. Adjustment and Barrel infiltration.

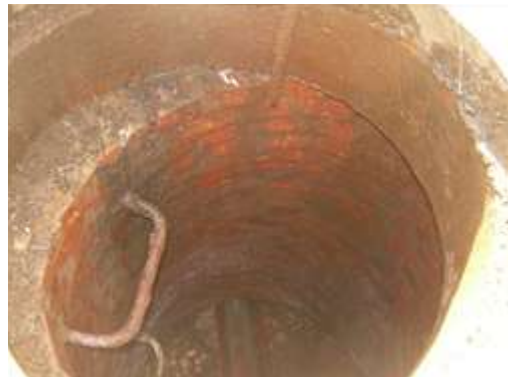
Defect

Frame leaks. Frame offset. Adjustment and Barrel infiltration.

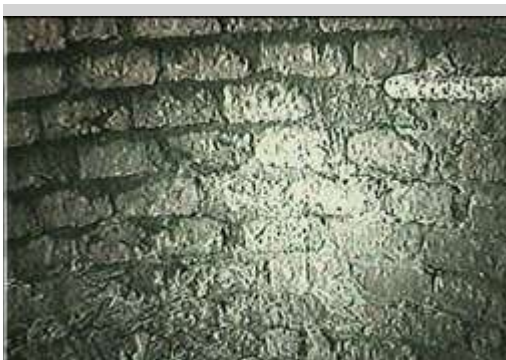
Defect

Barrel deterioration and infiltration.

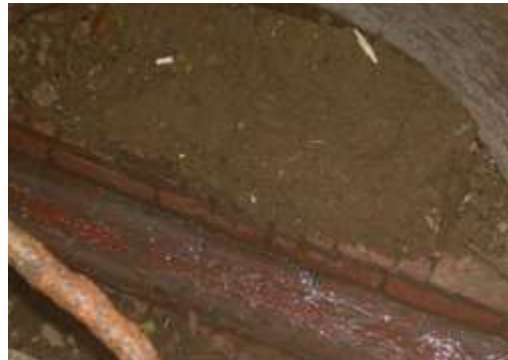
Defect

Heavy Bench debris.

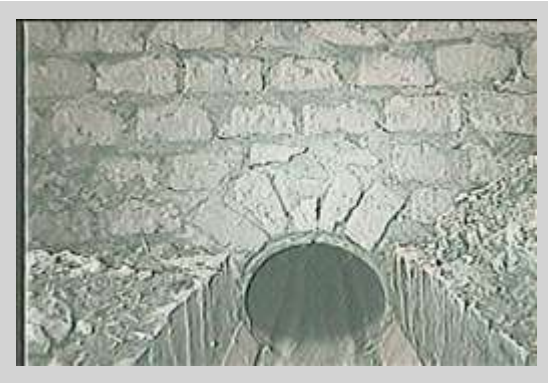
Pipe Out @ 12 O'Clock

Barrel deterioration and infiltration. Channel deterioration.

Infiltration: **Evidence** Pipe Seal Cond: **Cracked**

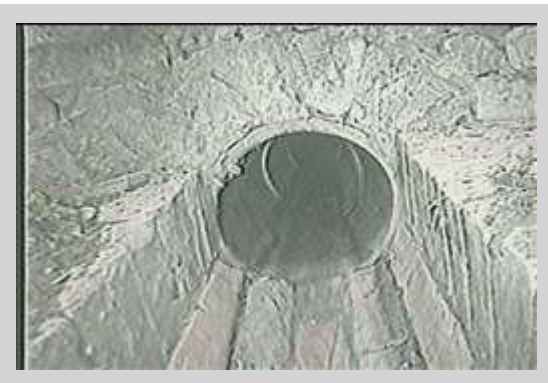
Pipe In @ 6 O'Clock

Channel deterioration.

Infiltration: **None** Pipe Seal Cond: **Cracked**
